**CZECH TECHNICAL UNIVERSITY IN
PRAGUE**

K L O K N E R I N S T I T U T E (K I)

Expert Report No. 1800 J 329	Date of issue of the report November 14, 2018	KI Department Department of Mechanics tel. +420 224 353 512
Client: SŽDC Stavební správa západ (SZCZ Civil Engineering Administration West) Sokolovská 278/1955 190 00 Prague 9		
Expert report: EVALUATION OF THE DIAGNOSTIC SURVEY OF THE BRIDGE STRUCTURES AT KM 3.706 – POD VYŠEHRADEM immovable cultural monument, CLCM Register No. 101315 (part)		
Author:	Ing. Milan Holý Ing. Dita Jiroutová, Ph.D. Doc. Ing. Jiří Kolísko, Ph.D. Ing. Petr Pokorný, Ph.D. Ing. Petr Tej, Ph.D.	
Principal Investigator:	Doc. Ing. Jiří Kolísko, Ph.D.	
Head of the Department:	Ing. Petr Tej, Ph.D.	
KI Director:	Doc. Ing. Jiří Kolísko, Ph.D.	
Copy number: 1 2 3 4 5	Divider: Client: 4x KI Archives: 1x

The report presents the results of the assessment of the diagnostic survey of the railway bridge under Vyšehrad SO 20-20-05 RAILWAY BRIDGE AT KM 3.706, Výtoň, prepared as part of the preparatory work for the reconstruction of the bridge by SUDOP PRAHA a. s.

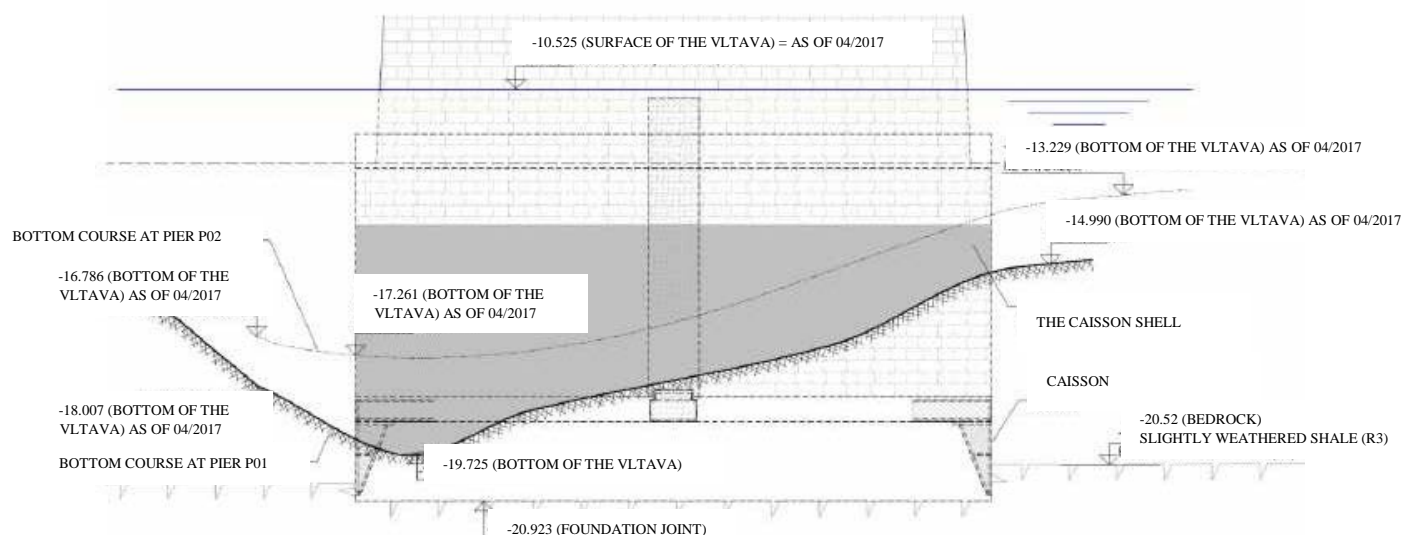
- Furthermore, the underwater survey showed that the bottom around Piers P01 and P02 is significantly scoured on the upstream side. The cavern reaches a depth of – 5.0 m, i.e. down to bedrock. The substructure of the caisson is also exposed. The cladding of the caisson shows extensive damage and deformation due to the effects of corrosion.

Bottom course (cavity on the upstream side) at Pier P01 and P02 as determined by underwater survey

- remediation of these faults is necessary as part of the repair work as soon as possible.
