**CZECH TECHNICAL UNIVERSITY  
IN PRAGUE  
KLOKNER INSTITUTE  
(KI)  
Šolínova 7, 166 08 Prague 6 - Dejvice**

<b>Expert Report No. 1900 J 059</b>	<b>Date of issue of the report</b>  23/10/2019	<b>KI Department</b>  Department of Mechanics tel. +420 224 353 512
<b>Client: SŽDC Stavební správa západ (SZCZ Civil Engineering Administration West)</b>  <b>Sokolovská 278/1955 190 00 Prague 9</b>		
<b>Expert report:</b>  <b>EVALUATION OF THE WORK AND ASSESSMENTS CARRIED OUT TO DATE TO THE LISTED RAILWAY BRIDGE AT KM 3.706 POD VYŠEHRADEM WITH THE PARTICIPATION OF A FOREIGN EXPERT</b>		
<b>Prepared by:</b>	Doc. Ing. Jiří Kolísko, Ph.D. Ing. Milan Holý Ing. Petr Tej, Ph.D.	
<b>Cooperation:</b>	Prof. Dr. Eugen Brühwiler, EPFL Doc. Pavel Ryjáček, Ph.D., et al. Faculty of Civil Engineering (FCE) of CTU Ing. Jan Kudláček, Ph.D., at al. Faculty of Mechanical Engineering (FME) of CTU Radek Pokorný, Applus Ing. Petr Pokorný, Ph.D.	
<b>Principal Investigator:</b>	Doc. Ing. Jiří Kolísko, Ph.D.	
<b>Head of the Department:</b>	Ing. Petr Tej, Ph.D.

**Fig. 1:** View of the railway bridge Pod Vyšehradem

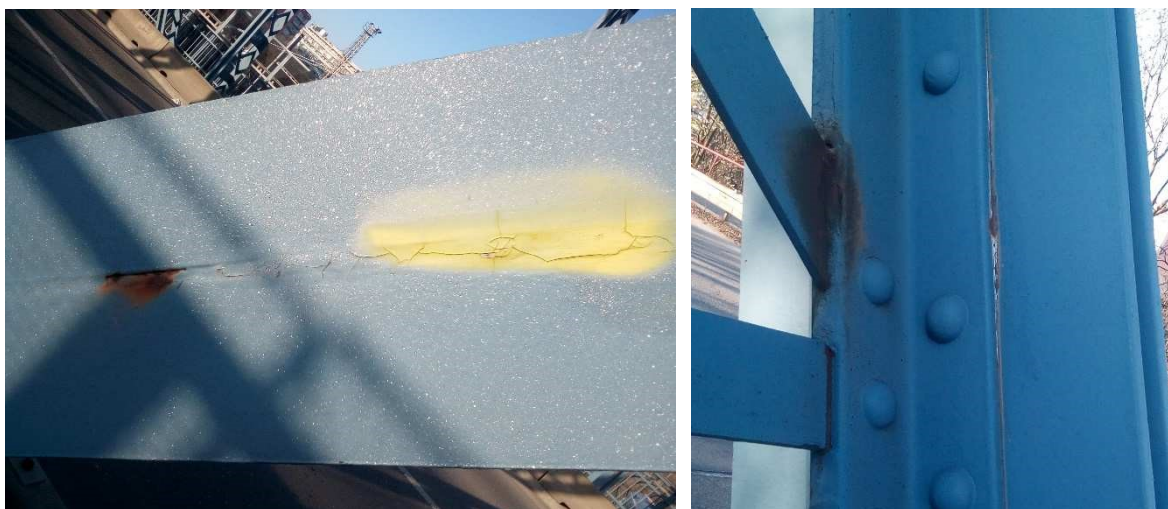
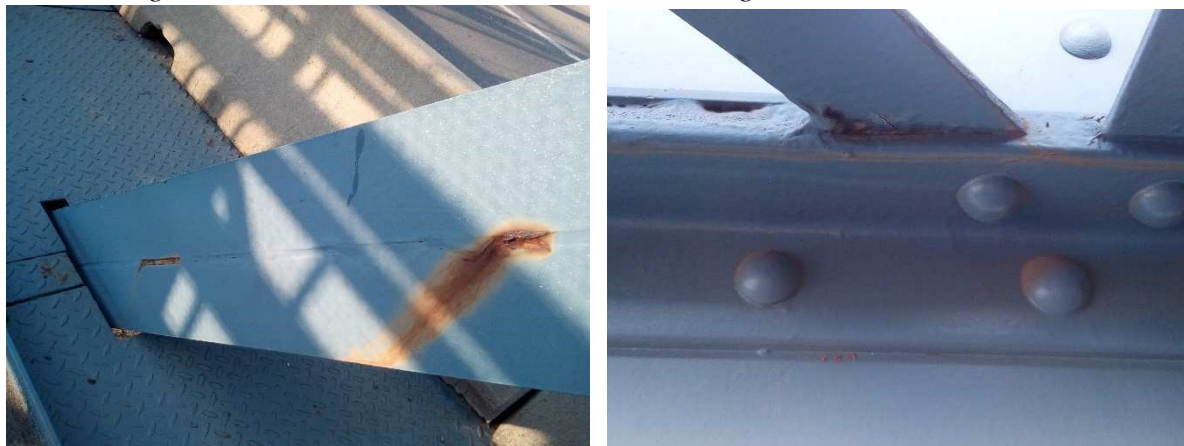
The existing steel bridge from 1914 had severely corroded rail-track elements, which reduced its load capacity. During the repairs completed in 2005, some of the longitudinal trusses, the upper chords of the supporting cross bars and some other steel elements of the rail-track were replaced. The original steel bearings were cleaned and preserved. A new concrete rail-track slab was constructed using filigree slabs over the entire bridge ground plan. The main beams and upper stiffening remained original as they were in quite good condition. The main beams are of similar composite cross-sections as those of the Pod Vyšehradem Bridge. The entire steel structure was sandblasted and a new corrosion protection with a four-layer coating was applied. At present (almost 14 years after the completion of the repair), CPC defects on the main beams and corrosion leaching are already visible – it is obvious that the filled gaps between the profiles of the perpendiculars and lacings are leaking and corrosion of the steel bearing structure of the bridge is occurring.

**Fig. 5:** Defects 13 years after reconstruction (photo from 2018) [SUDOP photo]  
**2.2.2 Railway viaduct Chrást (Plzeň-sever) [11]**

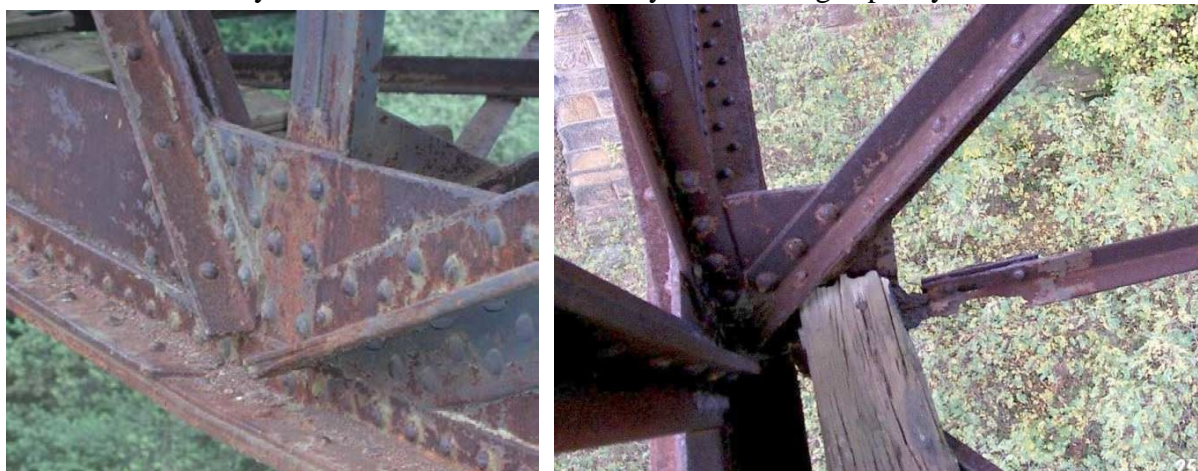
The structural condition of the bridge deteriorated over time due to degrading corrosion protection, which was last carried out in 1938, until it threatened to stop operation in 2003. The recalculation in 2000 established a crossing capacity of 80% of railway class A at a speed of 10 km/h. It was shown by recalculation of the load-bearing structure that repair of the load-bearing structure is necessary to eliminate the unsatisfactory load bearing capacity  $Z_{UIC} = 0.38$ .

**Fig. 8:** Details of the bridge structure before repair

In 2002–2003, therefore, a total repair of the bridge was carried out, which included repair of the superstructure including replacement of rails, repair of the structure including reinforcement and corrosion protection and repair of the horizontal surfaces of the storage sills of the substructure. The following modifications were proposed for all three steel structures: reinforcement of the main beams and longitudinal trusses, replacement of the upper and lower stiffening including the revision footbridge, replacement of the railings including the pavement planks.

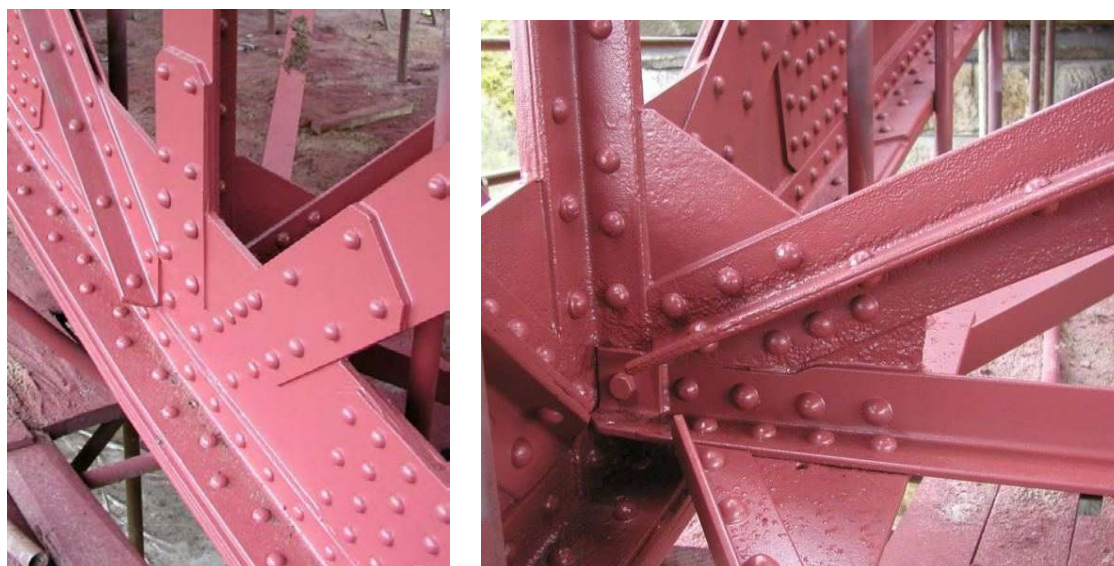
**Fig. 9:** Details of the bridge structure after repair

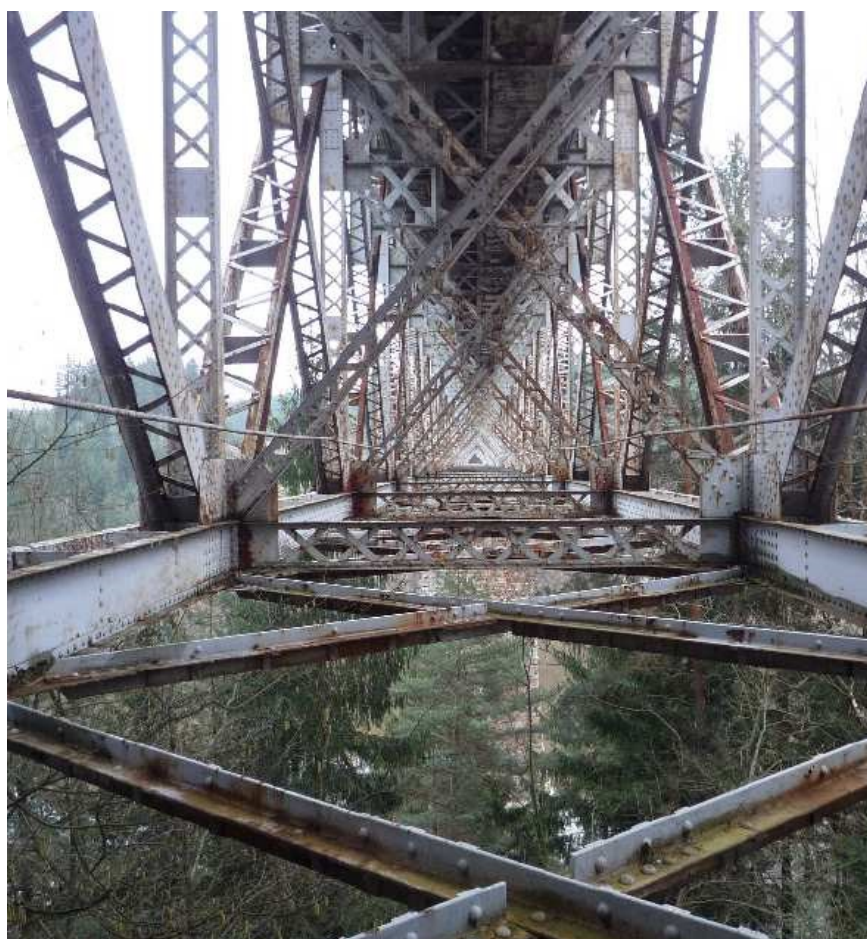
During a detailed inspection of the bridge (2014–15), significant failures were identified that were limiting to the remaining life of the bridge structure. In particular, the detail at the connection point of the truss coupling of the segmented rod between the pair of neck angles. Dirt settles in the narrow space of the crevice between the neck angles and the constant moisture causes corrosion of the entire neck angle flanges or significant corrosion loss. From the point of view of reparability, this is an unrepairable fault that can only be solved by replacing the entire element. The corrosion of these faults will worsen over time. From the point of view of load-bearing capacity, the detected defects are significant and significantly reduce the load-

bearing capacity of the rods, which will be further reduced by the development of corrosion. The inspection revealed a large extent of these failures. It concerns virtually all pier perpendiculars and mostly all drawn lacings. In many cases, the corrosion damage was covered by a thick layer of paint, but the paint was hollow at the point of failure and a hammer could be used to completely remove the corroded neck angle flange. Replacing all these affected elements to the extent identified would essentially be equivalent to fabricating a replica of the entire load-bearing steel structure. Another element that is significantly weakened by corrosion are the supporting cross bars, where corrosion loss of the neck angles occurs at the heading joint in the placing at the upper chord of the supporting cross bar. The failure can only be repaired by replacing the longitudinal trusses. During the static recalculation it was found that the structure is not able to carry the current standard loads, especially wind loads and brake force loads, which induce enormous additional stresses in the elements under consideration, which is mainly due to the absence of stiffeners that would transfer the load to the global system.

**Fig. 11:** View of the bridge axis at the level of the lower chord

Considering the structural condition of the steel structure and after evaluating the possibility of structural modifications, only local repairs without renewal of the coating system were proposed. The maintenance of the operational capability on the line was conditioned by the replacement of the steel structure with a comprehensive rehabilitation of the substructure within 5 years.

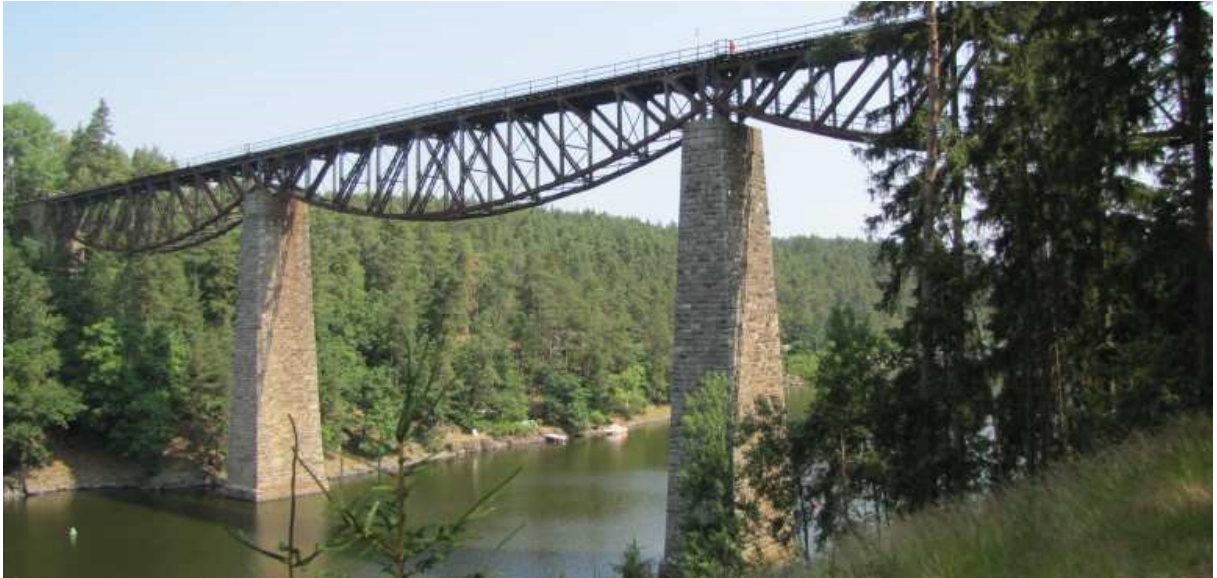
with about 7 trains per day. In 2015, an inspection found the bridge in a state of disrepair. Detailed corrosion inspection revealed uneven local corrosion losses, extensive corrosion weakening of the main load-bearing elements. On the basis of a static recalculation, it was shown that the bridge could no longer be kept in operation. It was decided to replace it with a new structure similar in shape, which was carried out this year.

**Fig. 12:** View of the bridge before reconstruction

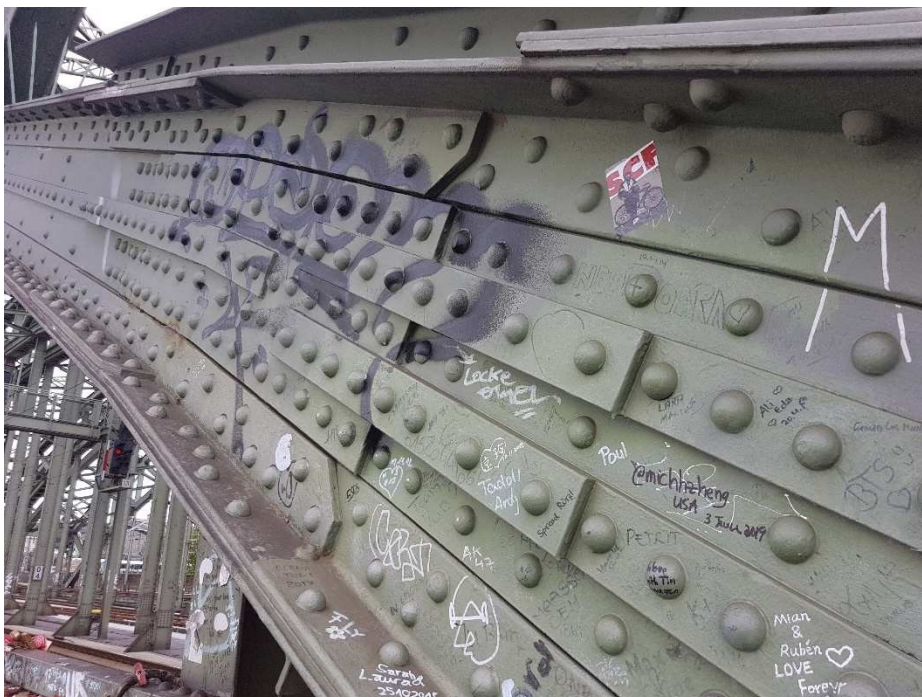
**Fig. 20:** Detail of the arch area with a high concentration of riveted joints and scabs

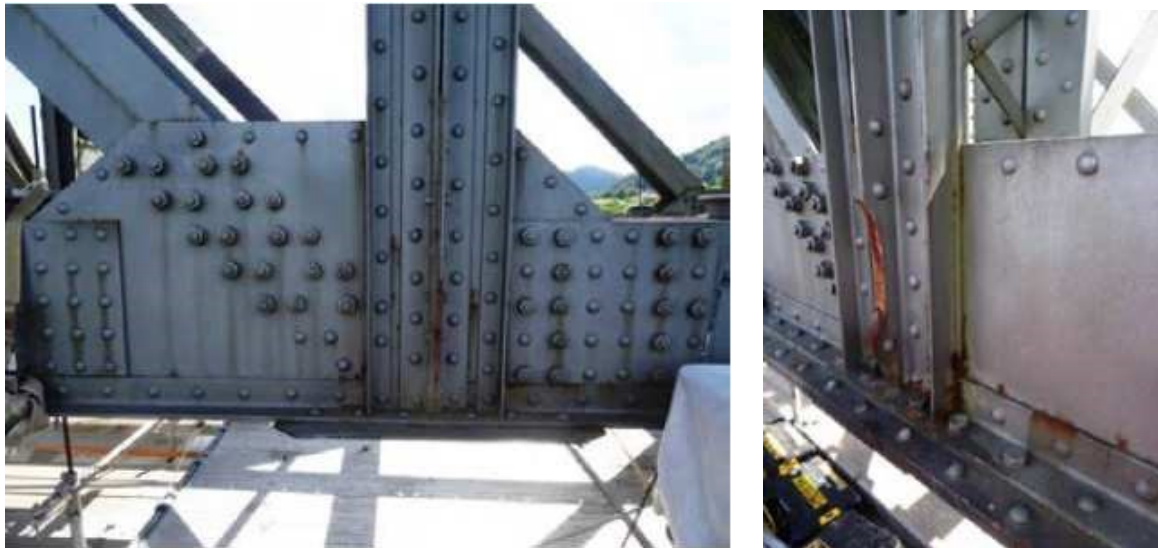
**Fig. 24:** View of the structure before the blasting – CPC on the surfaces is still functional, local corrosion is occurring, corrosion losses are still negligible

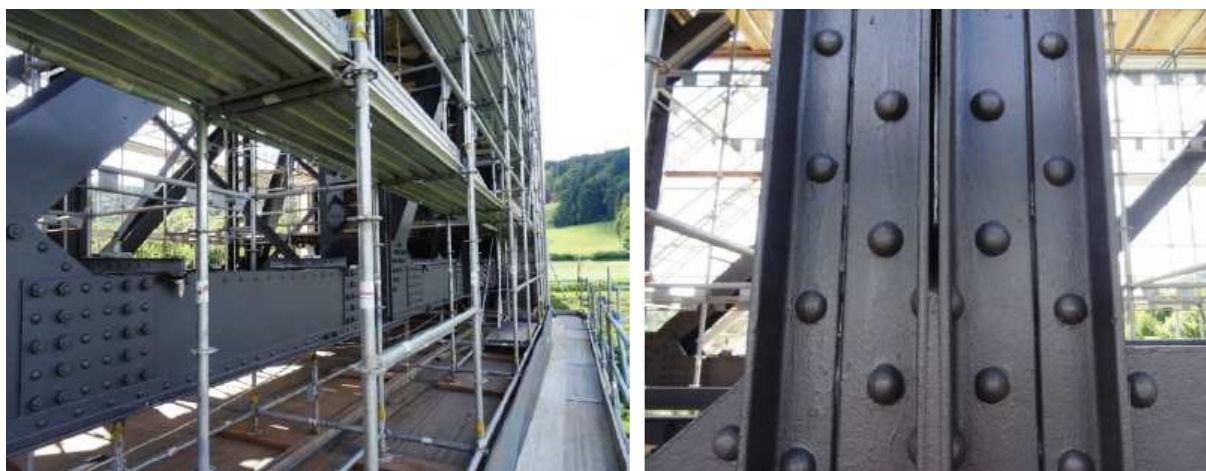
**Fig. 25:** View of the structure after application of the new CPC, on the right it is shown that it is possible to clean and apply CPC even in the narrow space between the plates without filling the joint
