Designation of the project: RECONSTRUCTION OF POD VYŠEHRADEM RAILWAY BRIDGES		Contract number: 16 354 201	
		Project level: PD	
Part: CONSTRUCTION PART BRIDGES, CULVERTS AND WALLS		Date: 04/2020	
Name of annex: TECHNICAL REPORT		Part number: E.1.4	Scale: -
		Number of formats: 101 x A 4	Annex number: 001

PROJECT: "Reconstruction of Pod Vyšehradem Railway Bridges"	
PART: E.1.4 – TECHNICAL REPORT – BRIDGE STRUCTURES	LEVEL: PD

Technical Report – Bridge Structures

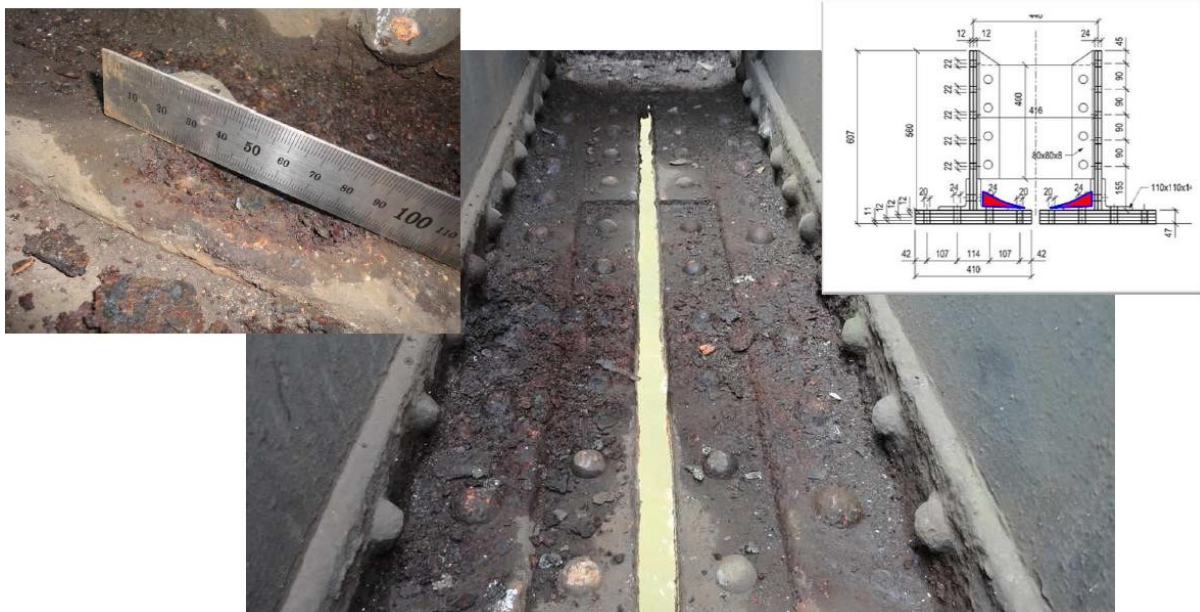
In the case of the lower chord, there are failures in the area of the panel points, where dirt accumulates and permanent corrosion occurs due to moisture and dripping water from the elements above the panel point. The insufficient gap between the lower chords does not allow dirt to fall off spontaneously. The most damaged parts are the flanges of the neck angles. There is also extensive damage to the horizontal splice plates.

Typical corrosion of the lower chords of the main beam

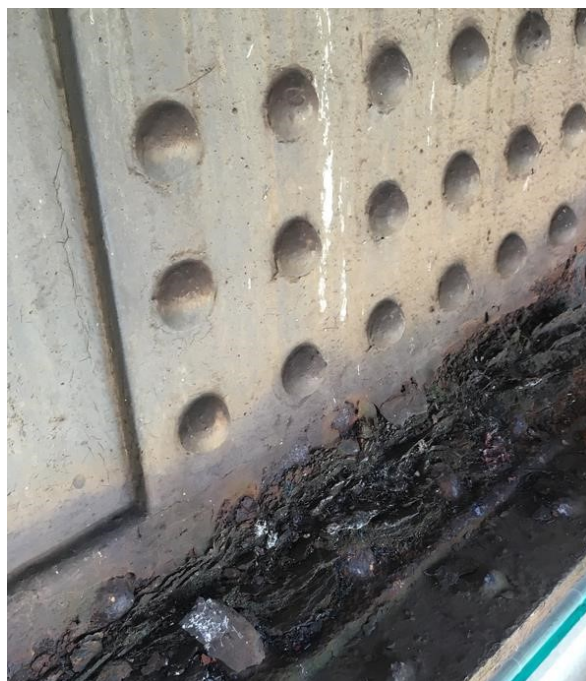
Corrosion of the neck angles of the lower chords in areas with constant moisture

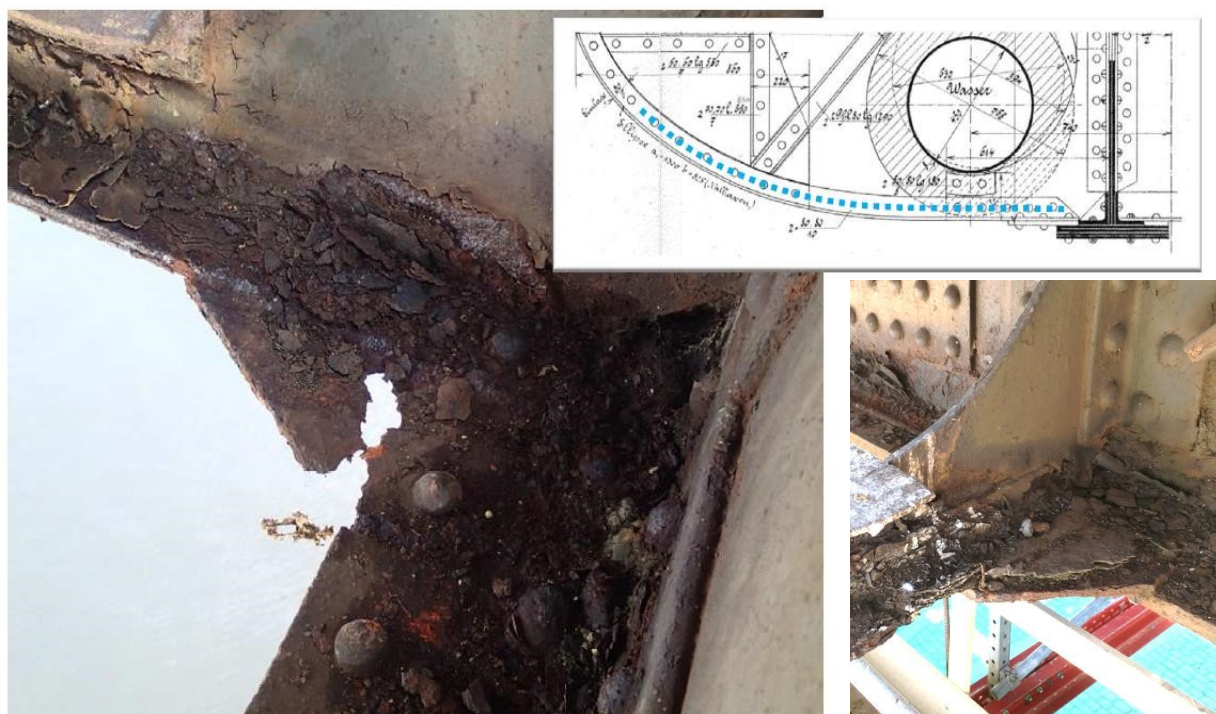
On the outside, corrosion weakening occurs at the sidewalk brackets, where water flows down the lower strip of the bracket to the lower strip (see figure below), which together with debris on the splice plate causes large corrosion losses. In some places the cantilevers of the footbridges are completely broken.

Corrosion of the lower chords in the pavement bracket connections

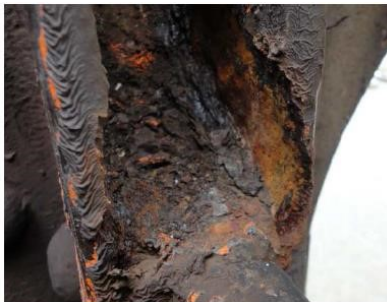
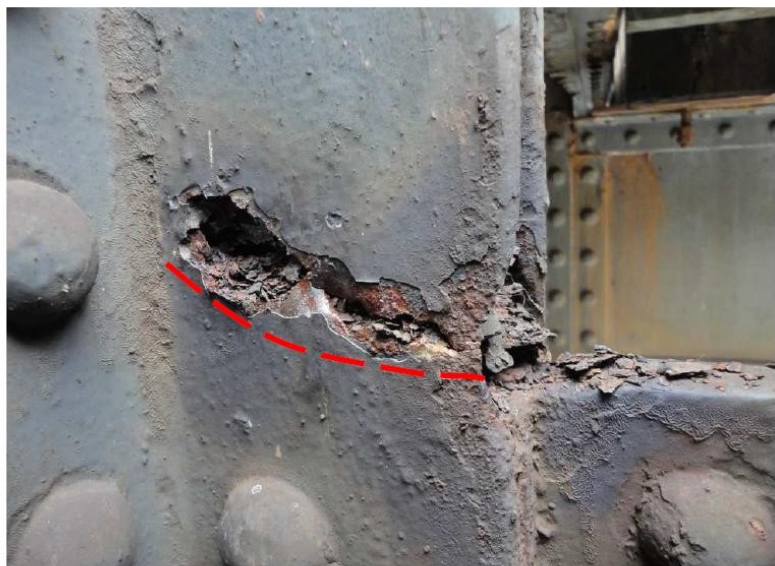
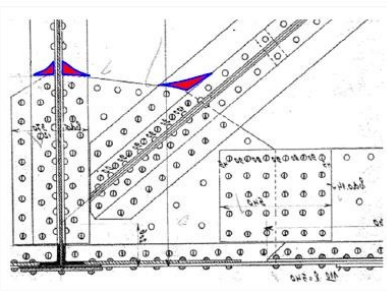
On the inside, there is a corrosion weakening at the point of the splice plate for the connection of the lower horizontal stiffening, where again the continuous action of moisture corrodes the lower chord and the splice plate itself.

These failures cannot be practically prevented even by intensive maintenance and it is only a matter of time before the corrosion damage reaches a limit state in terms of railway safety.

Corrosion in the connections of perpendiculars and lacings to the splice plates of the lower chord

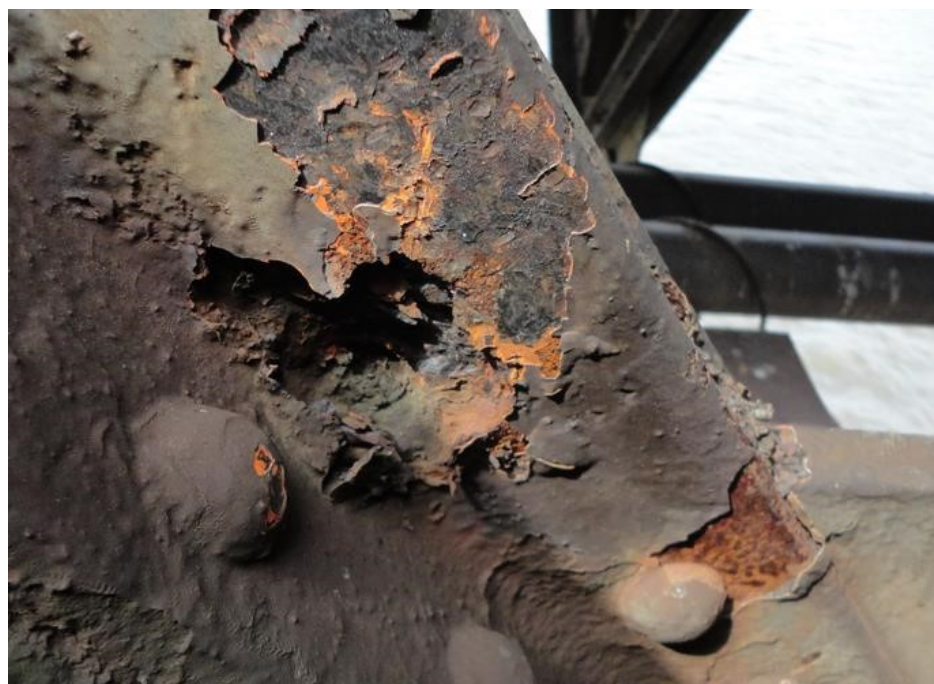
Corrosion at the connection of the lacing (NK2 – right D.7) to the splice plate of the lower chord U.7

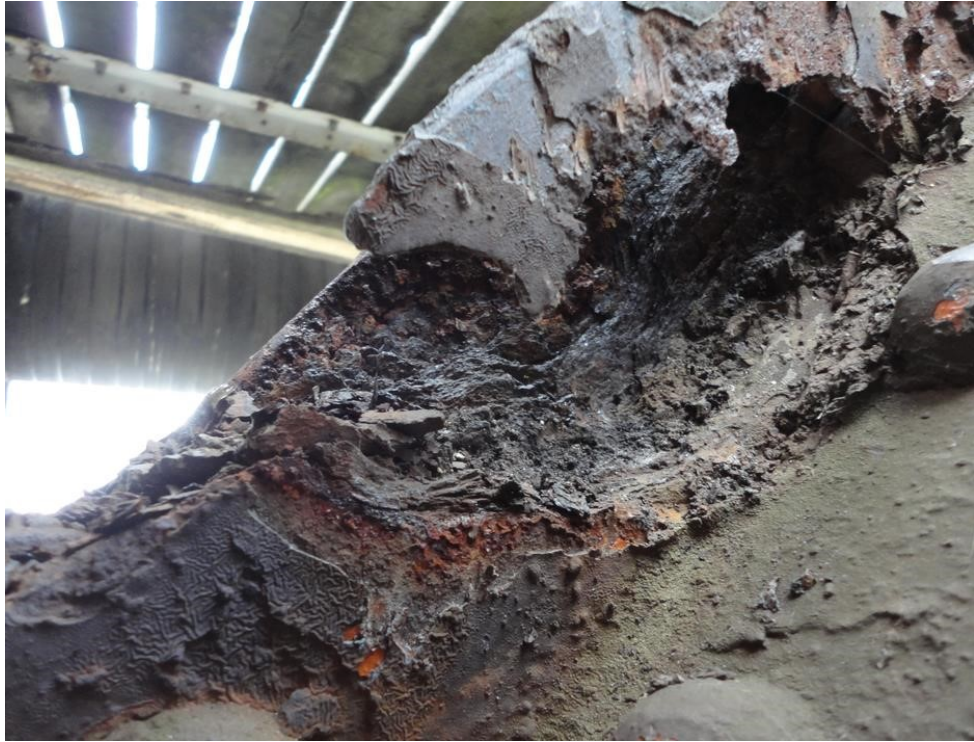
Corrosion at the connection of the lacing (NK1 – right D.7) to the splice plate of the lower chord U.7

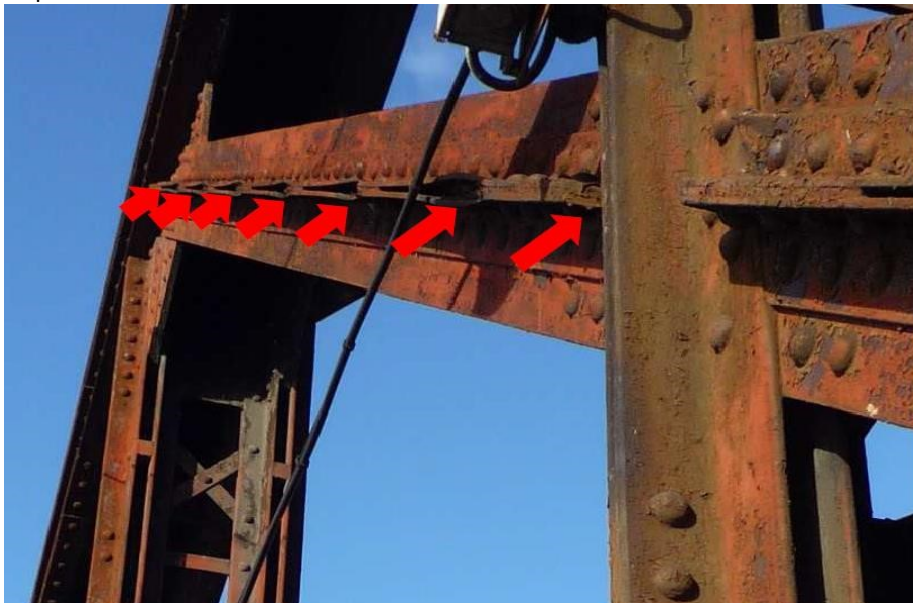
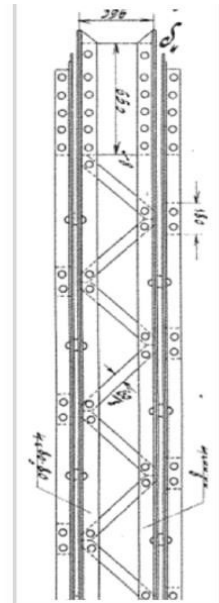
On the outside of the lacings, crevice corrosion is increasing to such an extent that the flanges are permanently deformed. The problem is again the high frequency of defects along the length of the element. The steel material reached its yield strength and was further permanently deformed (the steel material locally plasticised). Damaged parts of the rods must be replaced with new parts that are capable of acting flexibly. This defect can only be repaired by replacing part of the cross-section along the entire length of the rod, and the outer parts of the cross-section of the perpendiculars must also be removed for replacement.

Severe crevice corrosion in the connections of the couplings of the segmented rods of perpendiculars and lacings

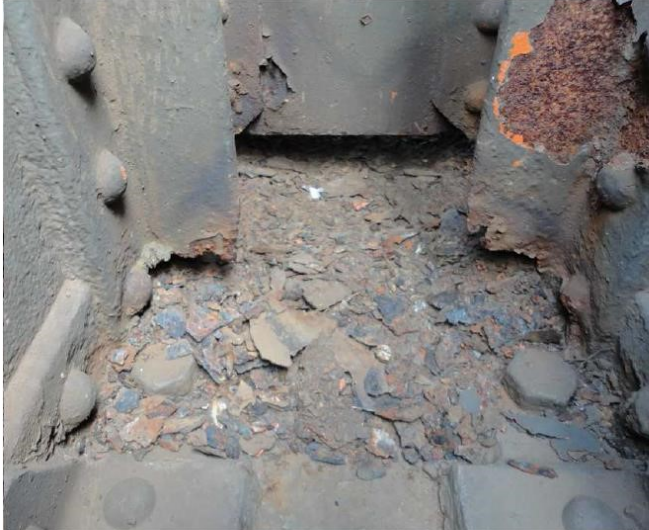
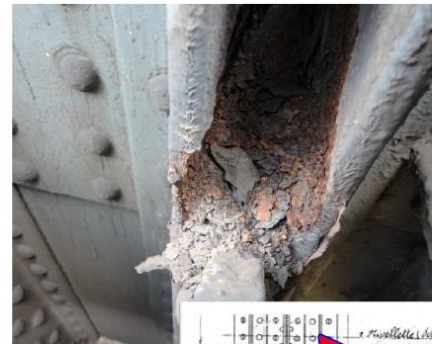
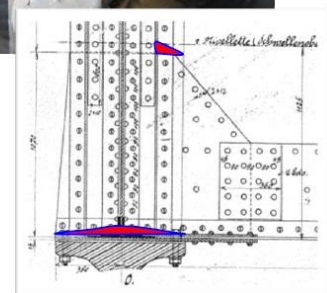
Massive corrosion loss occurs in the area of the end portal perpendiculars where the overlay splice plates are. Here, permanent humidity, high dirt fallout and minimal possibility of ventilation lead to significant corrosion losses. These elements also exhibit crevice corrosion at the connection to the splice plate of the bottom chord.

Corrosion of superstructure areas – portal perpendicular

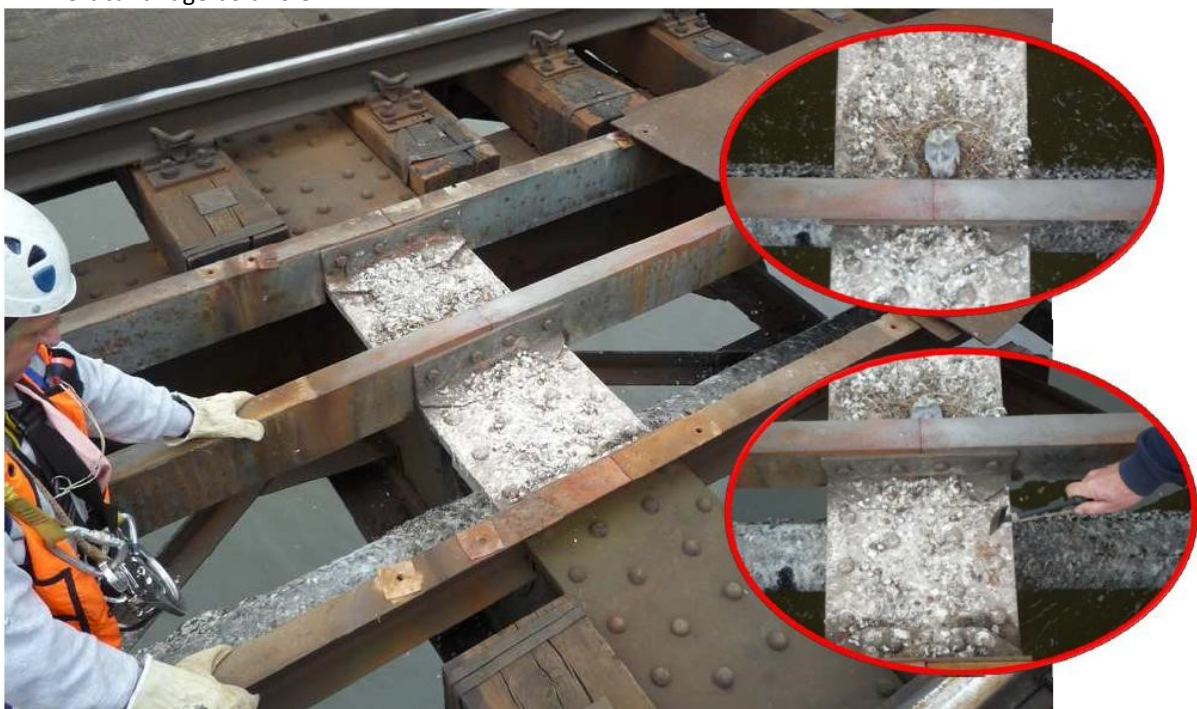
In the area of the rail-track, pitting corrosion of the supporting cross bar chords occurs, where the surface cross bar lamellas is corroded by the action of bird droppings and moisture. At the point where the bracing stiffeners are connected to the supporting cross bars, the supporting cross bar wall is corroded, again due to the effects of bird droppings and moisture. The splice plates of the lower horizontal stiffening and the bracing stiffening create conditions ("birdhouses") for nesting birds, especially pigeons. In the case of longitudinal trusses, corrosion of the upper chords occurs at the location of the bridge beams and the vertical bridge bolt hole.

Corrosion of the upper supporting cross bar chords due to pigeon droppings

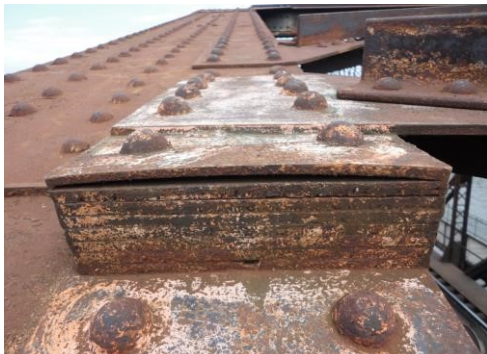
TYPICAL CORROSION OF THE UPPER CHORD

- DEFORMATION OF THE SPLICE PLATE STIFFENING CONNECTION

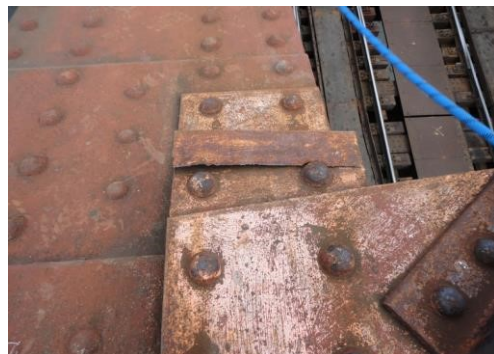
TYPICAL CORROSION OF THE UPPER CHORD

- TRANSVERSE CRACK IN THE UPPER SPLICE PLATE OF THE STIFFENING

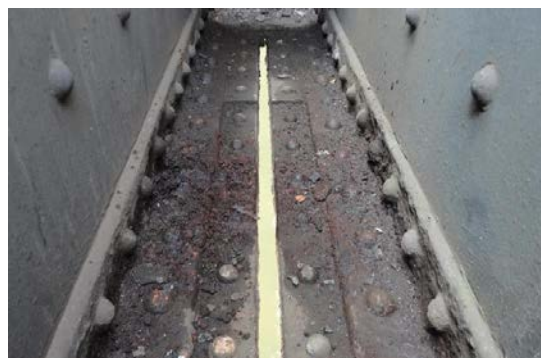
TYPICAL CORROSION OF THE LOWER CHORD IN THE SECTION BETWEEN THE PANEL POINTS

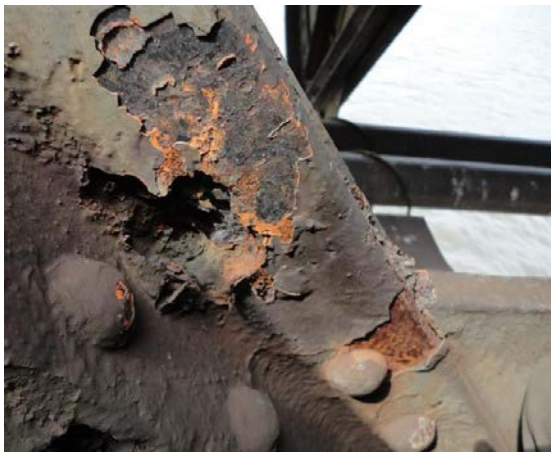
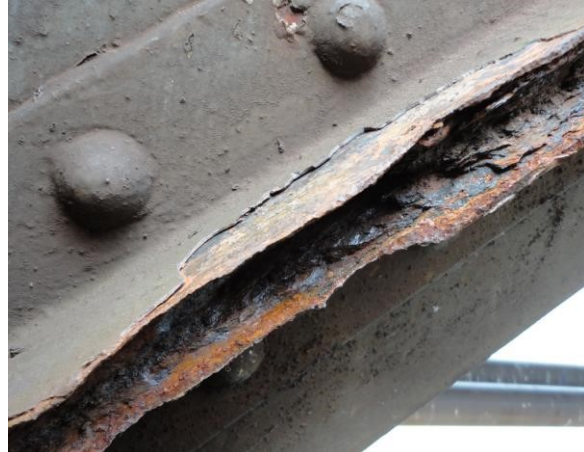
TYPICAL CORROSION OF THE LACING AT THE PANEL POINT WITH THE LOWER CHORD TYPICAL CREVICE CORROSION OF THE LACING

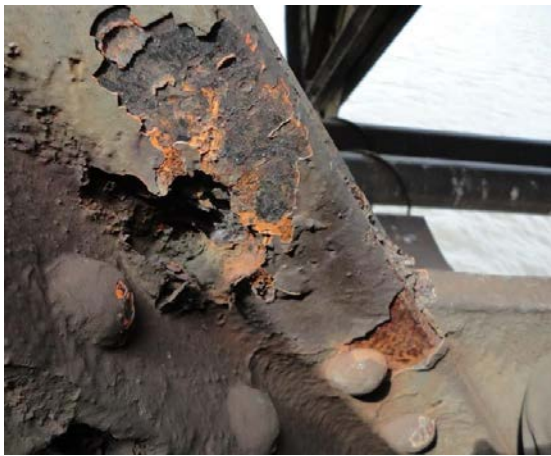
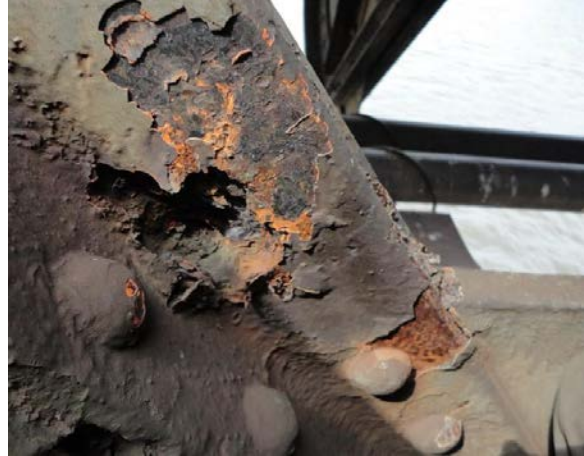
TYPICAL CORROSION OF THE LACING AT THE PANEL POINT WITH THE LOWER CHORD TYPICAL CREVICE CORROSION OF THE LACING

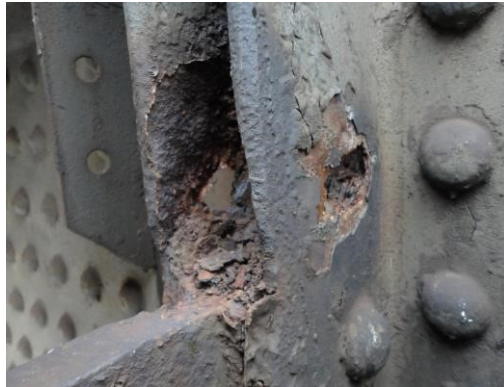
TYPICAL CORROSION OF THE PERPENDICULAR AT THE PANEL POINT WITH THE LOWER CHORD

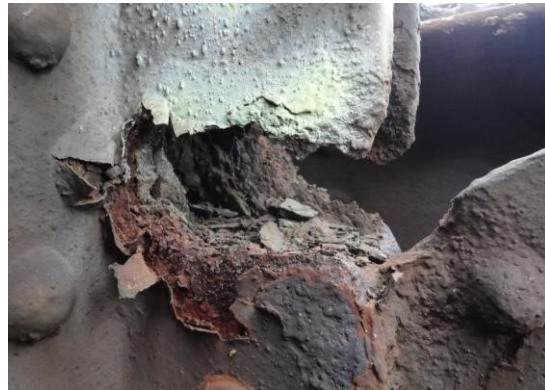
TYPICAL CREVICE CORROSION OF THE PERPENDICULAR

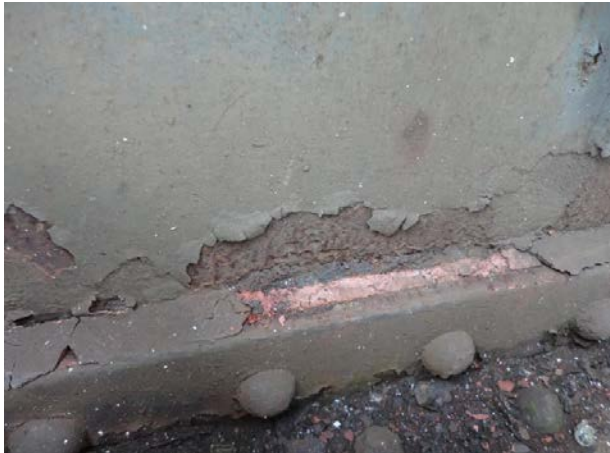
Photo: 2-9-7-02-2.JPG

TYPICAL CORROSION OF THE NECK ANGLES OF THE SUPPORTING CROSS BAR

- CORROSION OF THE WALL ABOVE THE NECK ANGLES

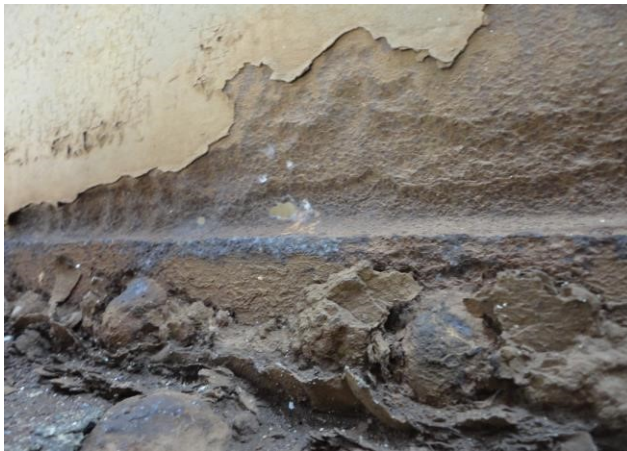
photo 2-10-15-05

TYPICAL CORROSION OF THE NECK ANGLES OF THE LONGITUDINAL TRUSS AT THE BRAKING STIFFENER CRACK IN THE UPPER CHORD

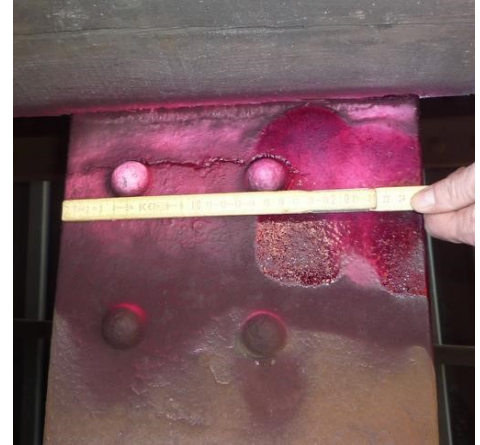
crack in the longitudinal truss chord L4.1 (NK1)

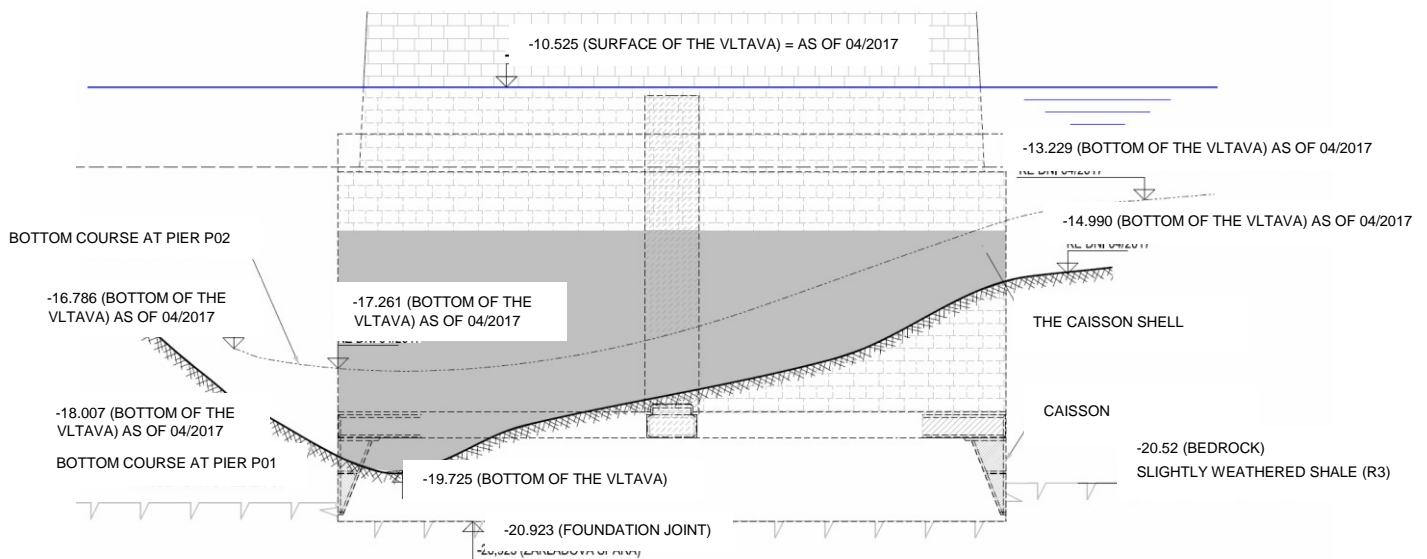
Bottom course (cavity on the upstream side) at Pier P01 and P02 as determined by underwater survey

- remediation of these faults is necessary as part of the repair work as soon as possible.
