Press release

According to experts from Czech Technical University, technical condition of the bridge is deteriorating. Recently replaced railway bridge in Děčín had similar problems, they point out

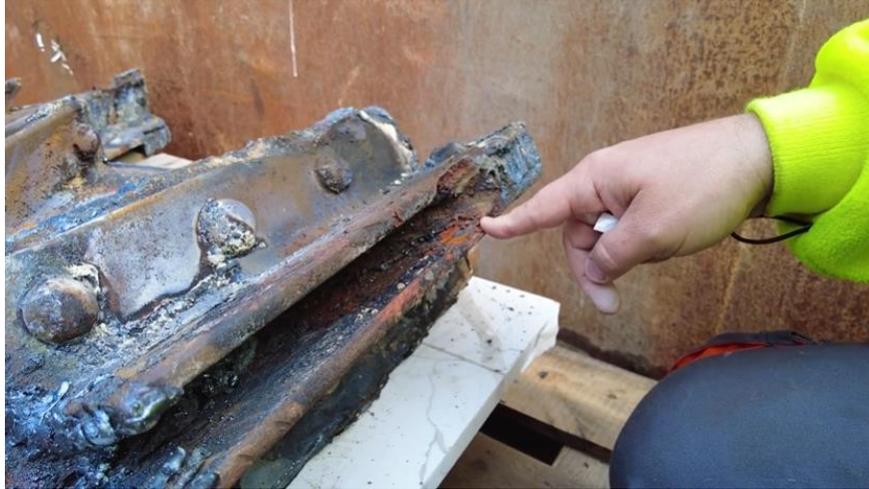
"The elements taken from the bridge in Děčín were exposed to relatively high corrosion. All of them have a similar character to those found on the bridge in Prague at Výtoň. After rigorous testing, we saw that there was no perfect blasting with either water or sand. In the joints and harder to reach parts of the treated structure, corrosion continues, albeit slower. Therefore, local problems with corrosion protection can be expected after about 5 years after the bridge has been treated. In other words, the steel structure is further degrading from the inside. These problems do not occur in the case of modern load-bearing elements," says Professor Pavel Ryjáček, Head of Department of Steel and Timber Structures at Faculty of Civil Engineering, CTU.

Photo source: video by Správa železnic, testing by Faculty of Civil Engineering, CTU
– corrosion in the place of the vertical of the Děčín bridge

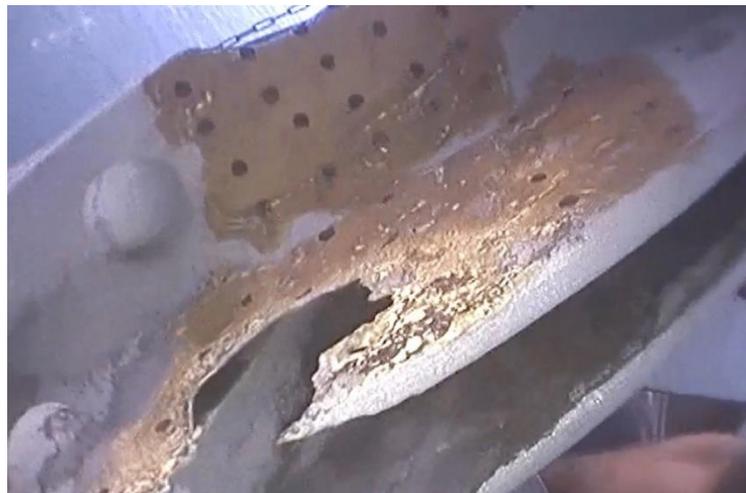
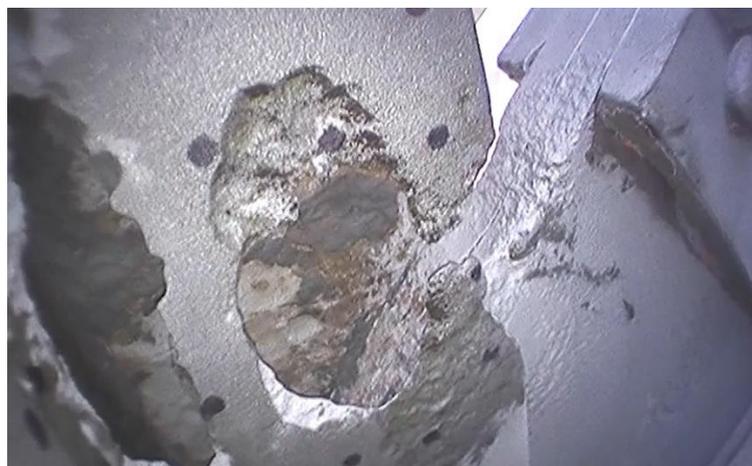
The action also includes an endoscopic survey of the internal spaces and crevices between the bars of diagonals. *"The testing conducted to date have shown significant corrosion damage, which in many cases has been covered by paint or corrosion products,"* Prof. Ryjáček adds.

Photo source: video by Faculty of Civil Engineering, CTU, corrosion captured by endoscopic probe on the diagonals of the Výtoň bridge, September 2023

"Recently, there has been an increase in emission phenomena that signalled the beginning of fatigue cracks. Therefore, it has now been decided to add additional sensors to the system. In addition, areas where fatigue cracks may form, we diagnose by cleaning with a high-pressure water blast. We then blast them with coarse-grained sand and then diagnose the cracks with an endoscope, measure the residual thickness of the material and use it as a basis for the subsequent static assessment," explains Prof. Ryjáček and adds that so far only fatigue cracks have been detected on the longitudinal members of the bridge deck. Furthermore, extensive corrosion, even corroding through, has been detected in the investigated areas. *"These are narrow, hard-to-clean, hard-to-repair places. Unfortunately, even when we deploy multiple cleaning options, we still do not have methods to paint or repair them in a long-term, high-quality anti-corrosive way. We do not even consider sealcoating and repainting because that will not solve the problem – the steel will continue to corrode under the sealant, it just will not show,"* Ryjáček means.
