**CZECH TECHNICAL UNIVERSITY  
IN PRAGUE  
KLOKNER INSTITUTE  
(KI)  
Šolínova 7, 166 08 Prague 6 - Dejvice**

<b>Expert Report No. 1900 J 059</b>	<b>Date of issue of the report</b>  23/10/2019	<b>KI Department</b>  Department of Mechanics tel. +420 224 353 512
<b>Client: SŽDC Stavební správa západ (SZCZ Civil Engineering Administration West)</b>  <b>Sokolovská 278/1955 190 00 Prague 9</b>		
<b>Expert report:</b>  <b>EVALUATION OF THE WORK AND ASSESSMENTS CARRIED OUT TO DATE TO THE LISTED RAILWAY BRIDGE AT KM 3.706 POD VYŠEHRADEM WITH THE PARTICIPATION OF A FOREIGN EXPERT</b>		
<b>Prepared by:</b>	Doc. Ing. Jiří Kolísko, Ph.D. Ing. Milan Holý Ing. Petr Tej, Ph.D.	
<b>Cooperation:</b>	Prof. Dr. Eugen Brühwiler, EPFL Doc. Pavel Ryjáček, Ph.D., et al. Faculty of Civil Engineering (FCE) of CTU Ing. Jan Kudláček, Ph.D., at al. Faculty of Mechanical Engineering (FME) of CTU Radek Pokorný, Applus Ing. Petr Pokorný, Ph.D.	
<b>Principal Investigator:</b>	Doc. Ing. Jiří Kolísko, Ph.D.	
<b>Head of the Department:</b>	Ing. Petr Tej, Ph.D.

**Fig. 1:** View of the railway bridge Pod Vyšehradem

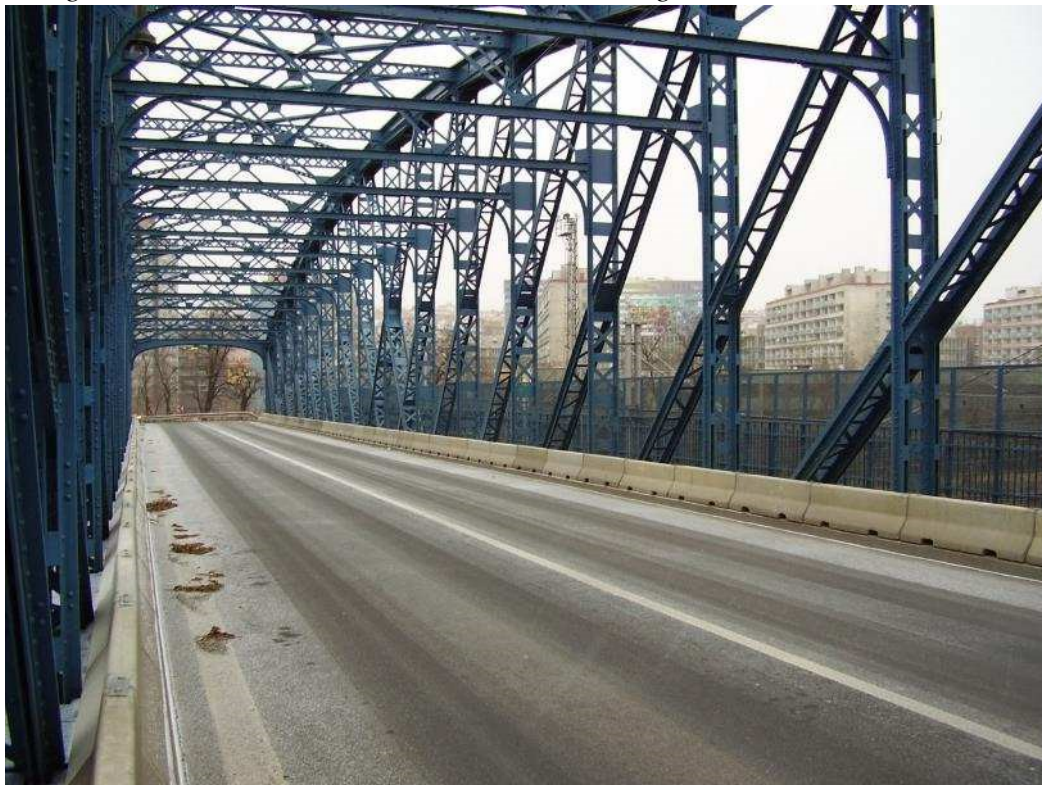
**Fig. 4:** Partial view of the bridge construction

The existing steel bridge from 1914 had severely corroded rail-track elements, which reduced its load capacity. During the repairs completed in 2005, some of the longitudinal trusses, the upper chords of the supporting cross bars and some other steel elements of the rail-track were replaced. The original steel bearings were cleaned and preserved. A new concrete rail-track slab was constructed using filigree slabs over the entire bridge ground plan. The main beams and upper stiffening remained original as they were in quite good condition. The main beams are of similar composite cross-sections as those of the Pod Vyšehradem Bridge. The entire steel structure was sandblasted and a new corrosion protection with a four-layer coating was applied. At present (almost 14 years after the completion of the repair), CPC defects on the main beams and corrosion leaching are already visible – it is obvious that the filled gaps between the profiles of the perpendiculars and lacings are leaking and corrosion of the steel bearing structure of the bridge is occurring.

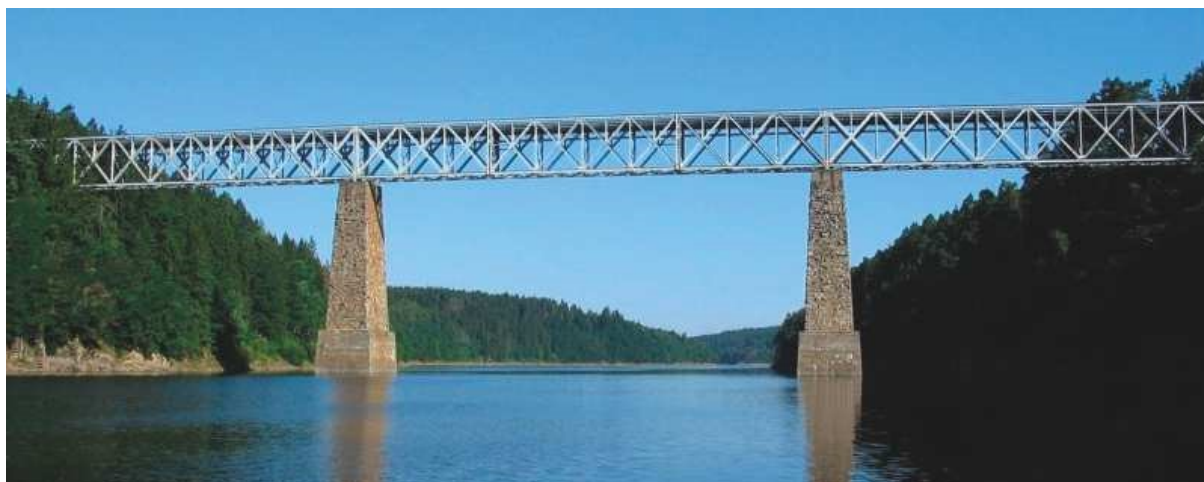
**Fig. 10:** View of the bridge

During a detailed inspection of the bridge (2014–15), significant failures were identified that were limiting to the remaining life of the bridge structure. In particular, the detail at the connection point of the truss coupling of the segmented rod between the pair of neck angles. Dirt settles in the narrow space of the crevice between the neck angles and the constant moisture causes corrosion of the entire neck angle flanges or significant corrosion loss. From the point of view of reparability, this is an unrepairable fault that can only be solved by replacing the entire element. The corrosion of these faults will worsen over time. From the point of view of load-bearing capacity, the detected defects are significant and significantly reduce the load-

bearing capacity of the rods, which will be further reduced by the development of corrosion. The inspection revealed a large extent of these failures. It concerns virtually all pier perpendiculars and mostly all drawn lacings. In many cases, the corrosion damage was covered by a thick layer of paint, but the paint was hollow at the point of failure and a hammer could be used to completely remove the corroded neck angle flange. Replacing all these affected elements to the extent identified would essentially be equivalent to fabricating a replica of the entire load-bearing steel structure. Another element that is significantly weakened by corrosion are the supporting cross bars, where corrosion loss of the neck angles occurs at the heading joint in the placing at the upper chord of the supporting cross bar. The failure can only be repaired by replacing the longitudinal trusses. During the static recalculation it was found that the structure is not able to carry the current standard loads, especially wind loads and brake force loads, which induce enormous additional stresses in the elements under consideration, which is mainly due to the absence of stiffeners that would transfer the load to the global system.

Considering the structural condition of the steel structure and after evaluating the possibility of structural modifications, only local repairs without renewal of the coating system were proposed. The maintenance of the operational capability on the line was conditioned by the replacement of the steel structure with a comprehensive rehabilitation of the substructure within 5 years.

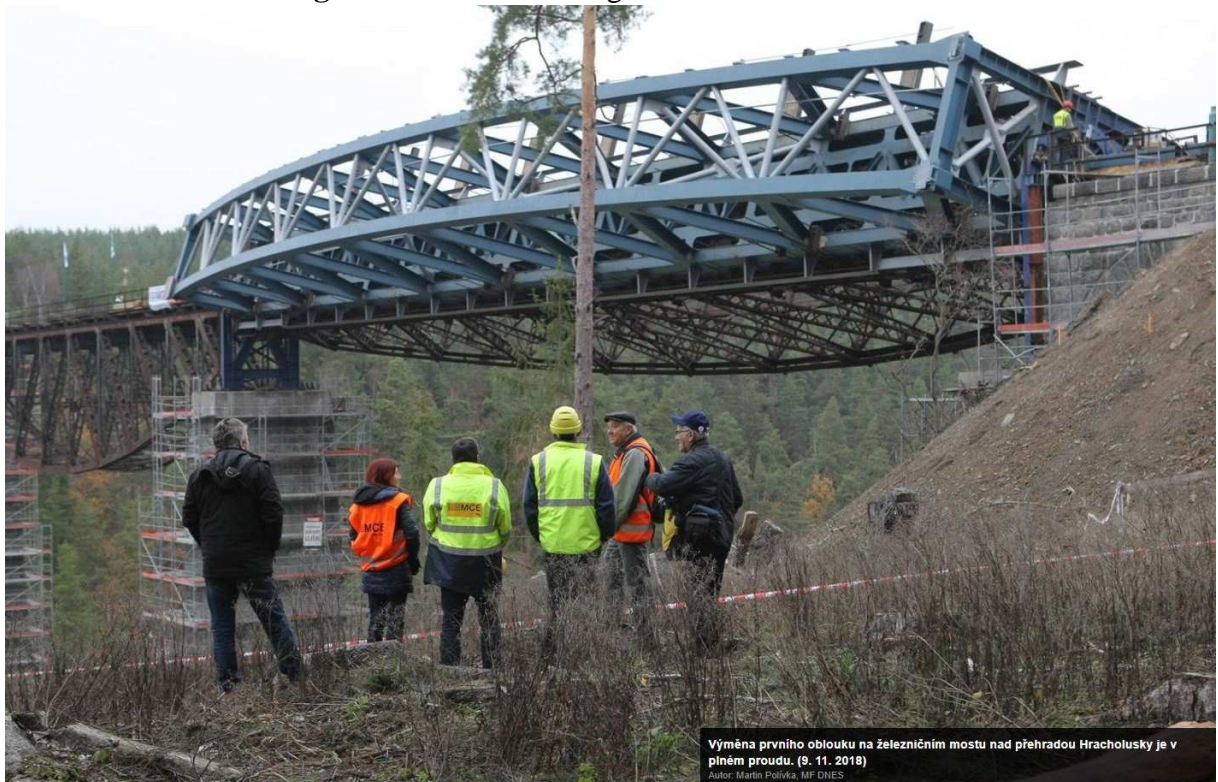
with about 7 trains per day. In 2015, an inspection found the bridge in a state of disrepair. Detailed corrosion inspection revealed uneven local corrosion losses, extensive corrosion weakening of the main load-bearing elements. On the basis of a static recalculation, it was shown that the bridge could no longer be kept in operation. It was decided to replace it with a new structure similar in shape, which was carried out this year.

**Fig. 13:** Replacing the first arch

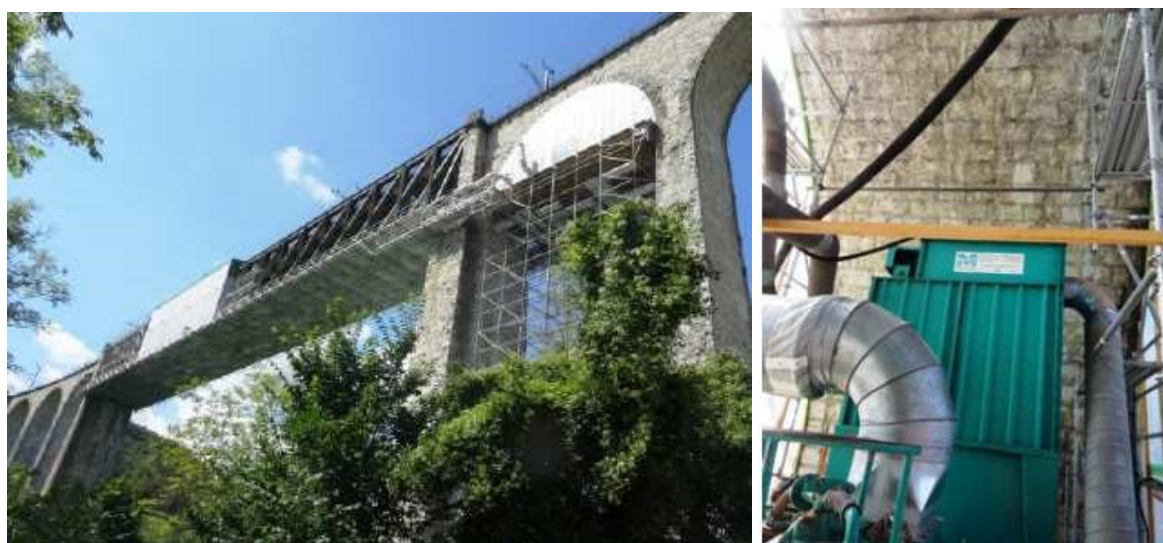
The CPC restoration in 2019 was carried out in four stages. The blasting of the structure was carried out in an airtight canvas covering (with a slight subatmospheric pressure in the area of canvas covering). The sandblasting residues were transported to a tent under the first stone arch where the blasted corrosion products (containing lead) and sand were separated and the sand was reused for blasting, see Figure 23.

**Fig. 23:** Airtight canvas covering, right view inside the canvas covering
