Designation of the project: RECONSTRUCTION OF POD VYŠEHRADEM RAILWAY BRIDGES		Contract number: 16 354 201	
		Project level: PD	
Part: CONSTRUCTION PART BRIDGES, CULVERTS AND WALLS		Date: 04/2020	
Name of annex: TECHNICAL REPORT		Part number: E.1.4	Scale: -
		Number of formats: 101 x A 4	Annex number: 001

PROJECT: "Reconstruction of Pod Vyšehradem Railway Bridges"	
PART: E.1.4 – TECHNICAL REPORT – BRIDGE STRUCTURES	LEVEL: PD

Technical Report – Bridge Structures

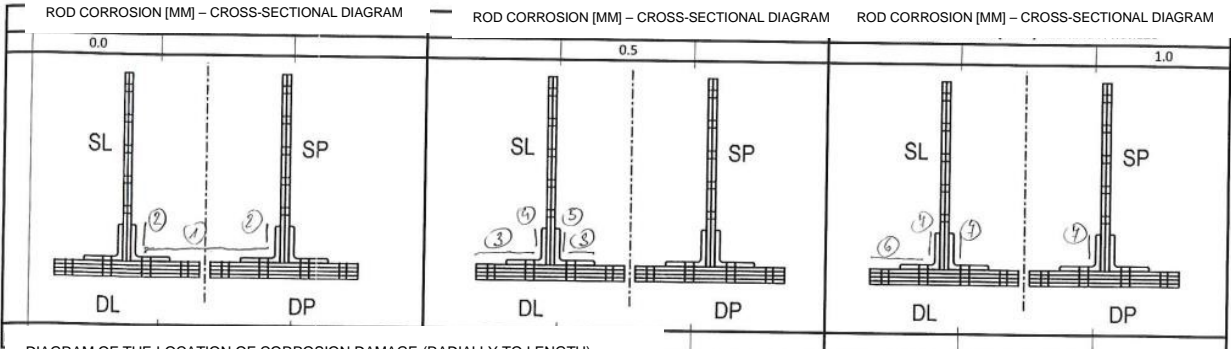
NK NO.: 2 (2) TRUSS NO.: 8

DIAGRAM OF THE LOCATION OF CORROSION DAMAGE (RADIALLY TO LENGTH):

CORROSION WEAKENING OF RODS (RELATIVE K UDELLE):			
SP:	(1) oslabení 2 mm	(3) oslabení 2 mm	(6) oslabení 2 mm
DP:	(2) oslabení 80 mm oslabení 3 mm	(4) oslabení 60 mm oslabení 3 mm	(4) oslabení 80 mm oslabení 3 mm
DL:		(5) oslabení 80 mm oslabení 3 mm	
DL:

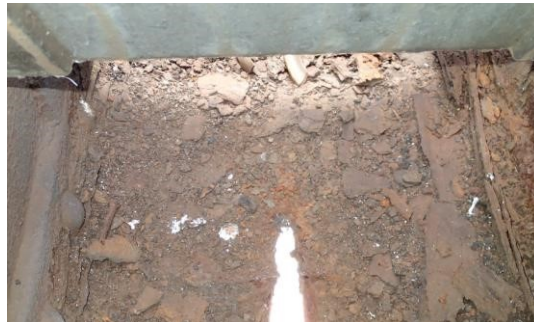
TYPICAL CORROSION OF THE LOWER CHORD IN THE SECTION BETWEEN THE PANEL POINTS

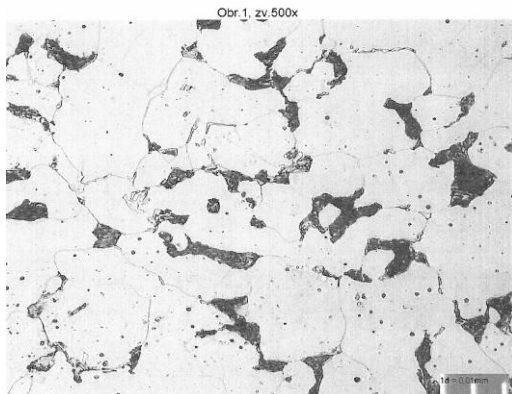
After grinding and polishing, a photo microstructure of the steel grains was taken on the samples. From the results, the **Ferritic-perlite structure with cementite** was evaluated for the sheet and angle samples.

Sample sheet metal – 500 x enlarged

It was confirmed by metallographic tests that it is **plow steel**.

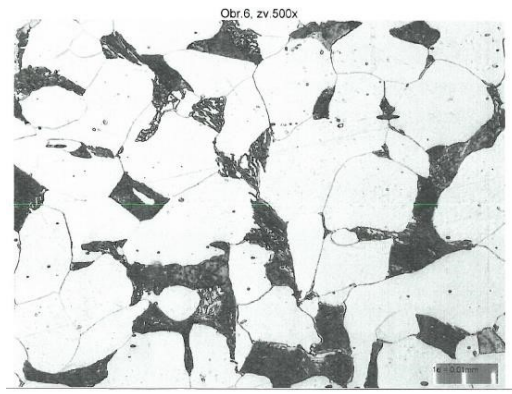
Angle sample – 500 x enlarged

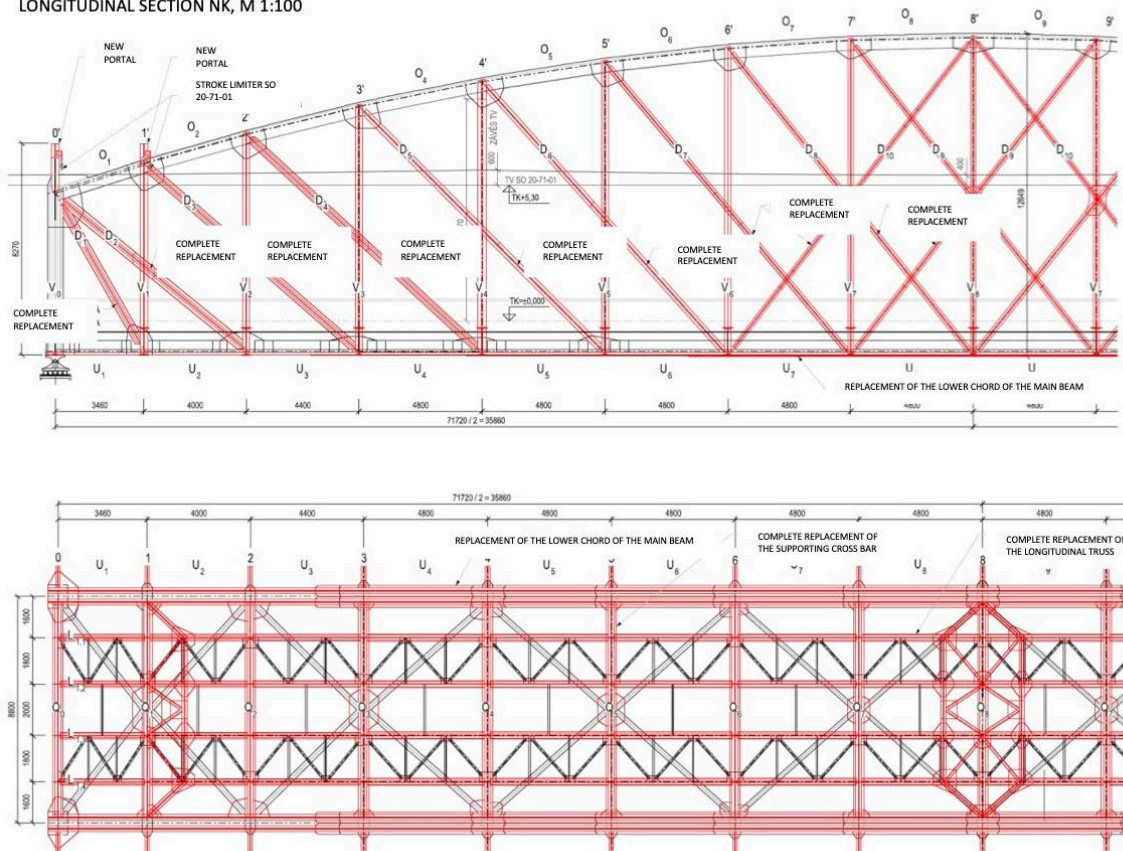
LONGITUDINAL SECTION NK, M 1:100

Reconstruction design – elements to be replaced (in red) of the steel bridge structure at km 3.706

The reconstruction also includes the replacement of the pedestrian bridge brackets (see SO 20-20-05.1). The consoles will be delivered completely new in the external shape corresponding to the condition. An external ledge with a railing and an internal string course will be used in reverse. The inner railings will be replaced with new ones meeting the requirements of ČSN 73 6201 for the separation of railway and pedestrian traffic. The walking surface will be replaced with a steel walking surface, possibly with the addition of a hardwood walking surface.

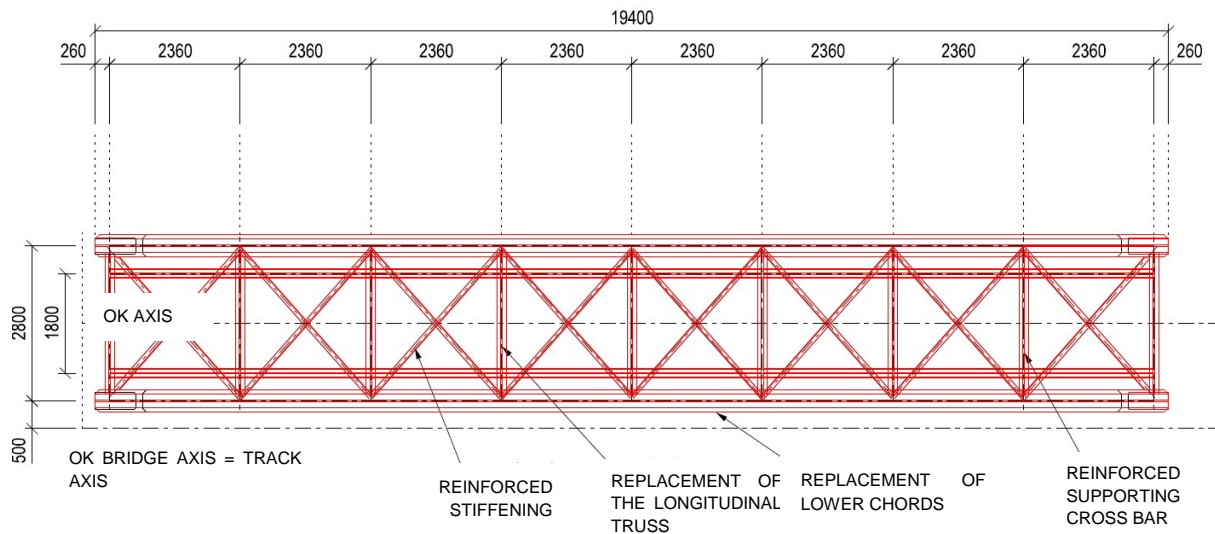
Reconstruction design – elements to be replaced (in red) of the steel structure NK1–NK3 of the bridge at km 3.545

In bays 1 to 3, the floor section will be supplied in new sheet metal to replace the existing timber floor.

The total weight of the parts to be replaced is expected to be 53% i.e. $3 \times 32 \text{ t} \sim 96 \text{ t}$ for NK1 to NK3 and 22% i.e. 14t for NK4. In total, $\sim 110 \text{ t}$ of elements will need to be replaced, which is on average 46% of the total weight.

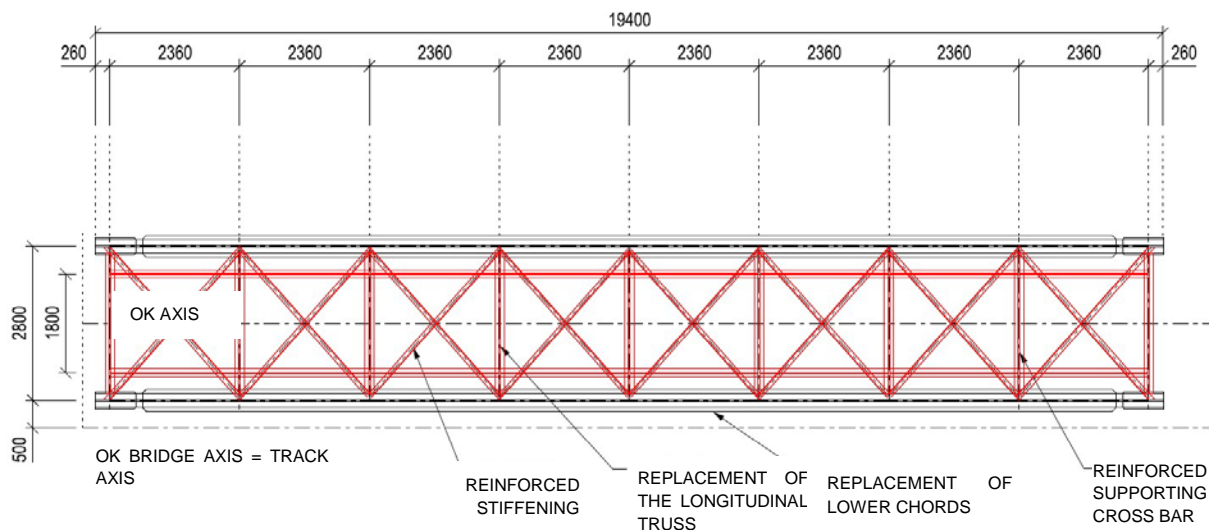
Reconstruction design – elements to be replaced (in red) of the steel structure of the NK4 bridge at km 3.545
